The “Lightning” Newsletter

Volume 4, Number 3
March, 2011

Service Bulletin AASB-1-1-2011

SERVICE BULLETIN	
Service Bulletin #	AASB-1-1-2011
Superseded Bulletin #	n/a
Issue Date	1-31-2011
Effective Date	1-31-2011
Limitations for Completion	Next scheduled inspection
Make & Model Affected	Lightning LS-1 SLSA &ELSA
	SN78 thru 107

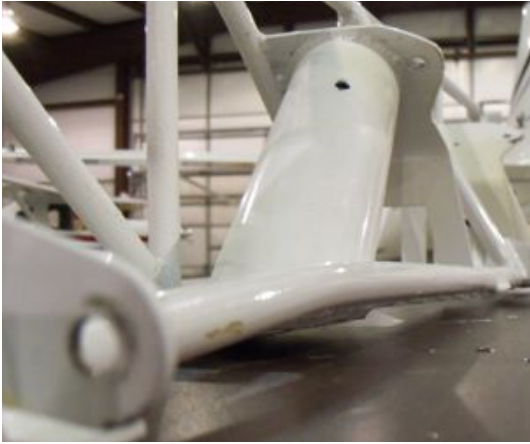
Figure 1: deformation of rear ½” tube box V1 socket plate V1

Refer to figure 1: The lowest and most aft tube adjacent to the gear plate must be inspected. This tube is about ½” in diameter and should be flat with no upwards bowing to it. If deformed upwards it will be the greatest at the outboard end of the lower socket plate. Use a straight edge on the tube to determine if it is bent. Any deformation in this tube is cause for replacement.

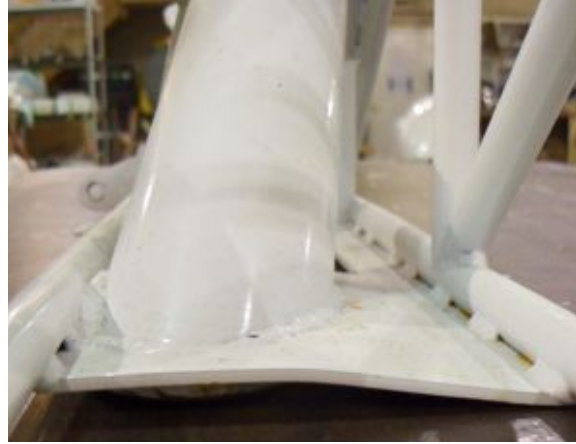
Figure 2: deformation of lower socket plate V1

Refer to figure 2: The lower socket plate must be inspected as well. This plate may have up to 1/16” flex upwards and be with in serviceable tolerance. However should more than

that be found upon inspection the box should be replaced. Check by using a short straight edge set between the spar box tubes across the plate. Measure the deflection if any.

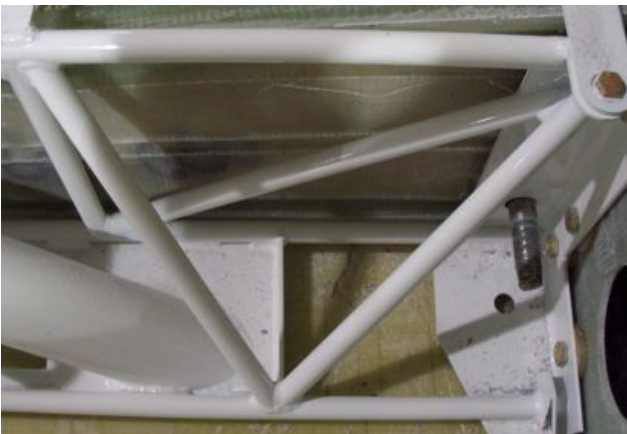
Figure 3: Compression tubes added V2 plate V2

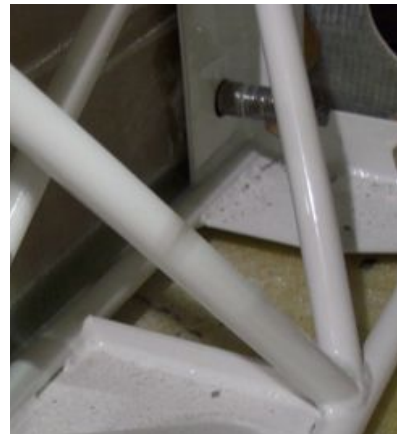
Figure 4: Gusset added to lower plate V2
